<b>HYUNDAI</b> <b>Technical Service Bulletin</b>	GROUP <b>CAMPAIGN</b>	NUMBER <b>18-01-032-2</b>
	DATE <b>DECEMBER 2018</b>	MODEL(S) <b>SONATA (LF) SANTA FE SPORT (AN)</b>
<b>SUBJECT:</b> SONATA / SANTA FE SPORT ENGINE DTC P1326 - WIRING INSPECTION / INSTALLATION AND ENGINE REPLACEMENT (SERVICE CAMPAIGN T3G)

This TSB supersedes TSB# 18-01-032-1 and modifies the Part Information table.

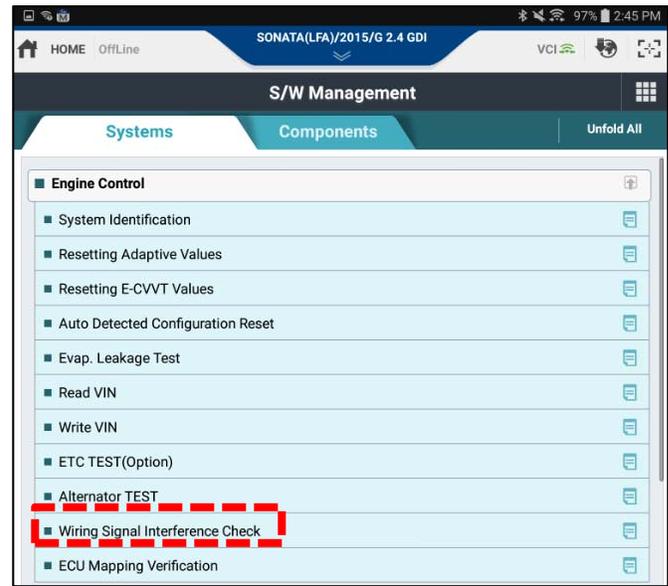
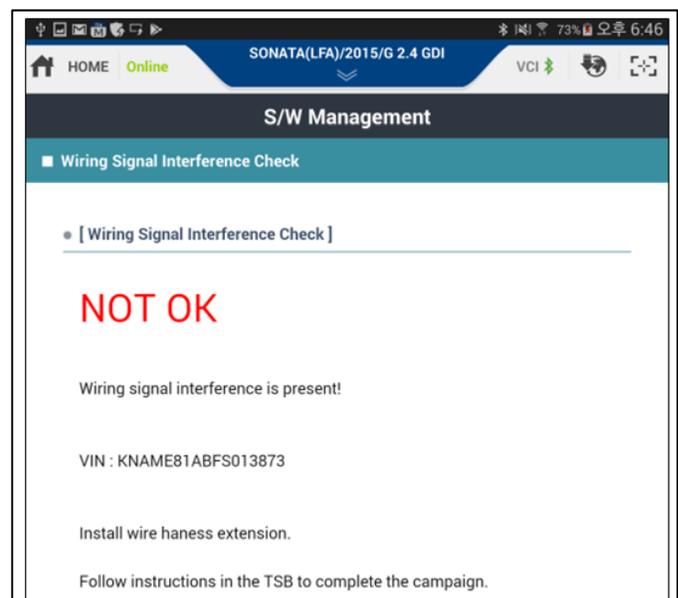
**If the inspection result is NOT OK:**

- Install the new wire harness extension kit.
