<b>HYUNDAI</b> <b>Technical Service Bulletin</b>	GROUP <b>CAMPAIGN</b>	NUMBER <b>18-01-032-2</b>
	DATE <b>DECEMBER 2018</b>	MODEL(S) <b>SONATA (LF) SANTA FE SPORT (AN)</b>
<b>SUBJECT:</b> SONATA / SANTA FE SPORT ENGINE DTC P1326 - WIRING INSPECTION / INSTALLATION AND ENGINE REPLACEMENT (SERVICE CAMPAIGN T3G)

This TSB supersedes TSB# 18-01-032-1 and modifies the Part Information table.

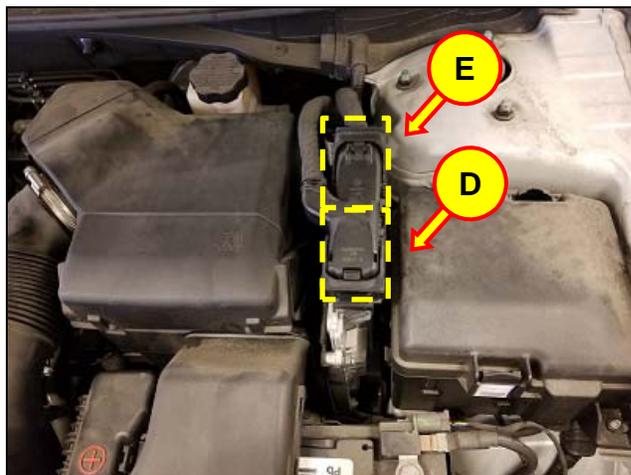
Remove ECM connector (D) and top cover by gently prying on tab (F) using a flat head screwdriver.

**DO NOT use brute force when removing the ECM connector cover. The cover comes off with minimal force when using the release tab(s) (F).**

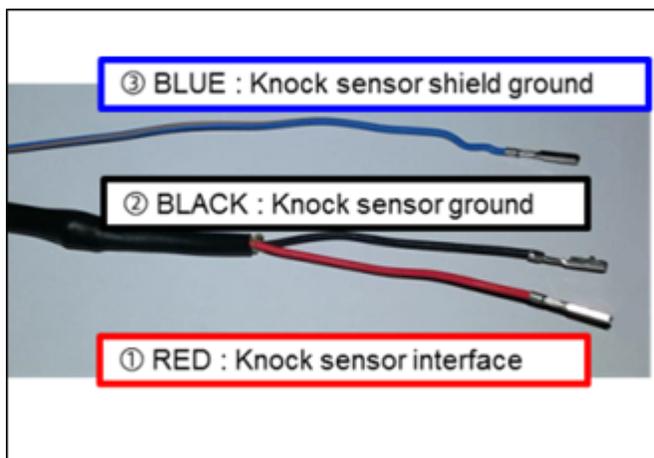
Ensure the new pins are installed in the same orientation as they were removed.

11. Cut off and discard the (3) original terminals from the ECM connector and fold the original wires (K) back onto the original engine control wire harness and secure with tape. Secure any excess wire from the new wire harness extension onto the original engine control wire harness with tape.

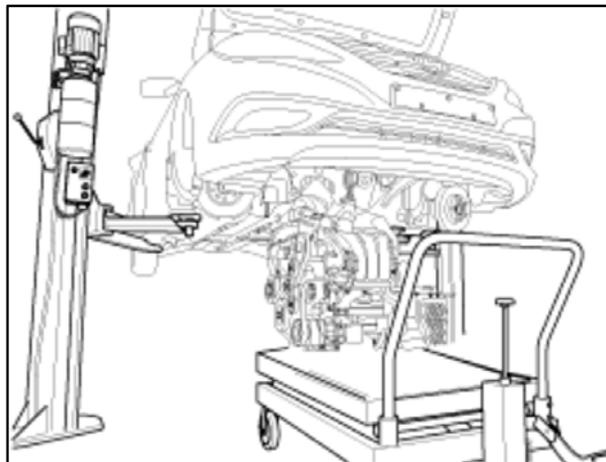
1. **If DTC P1326 is detected and the wiring signal interference inspection indicates engine replacement is required**, replace the Sub Engine Assembly (long block).
2. Follow the published Service Information from the applicable **Shop Manual** to remove the Sub Engine Assembly from the vehicle.

- Engine Mechanical >
- Engine And Transaxle Assembly >
- Engine And Transaxle Assembly >
- Repair Procedures**

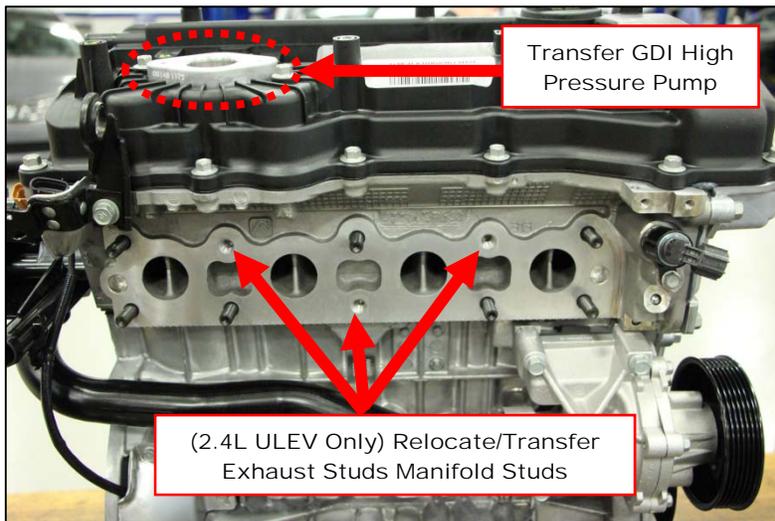
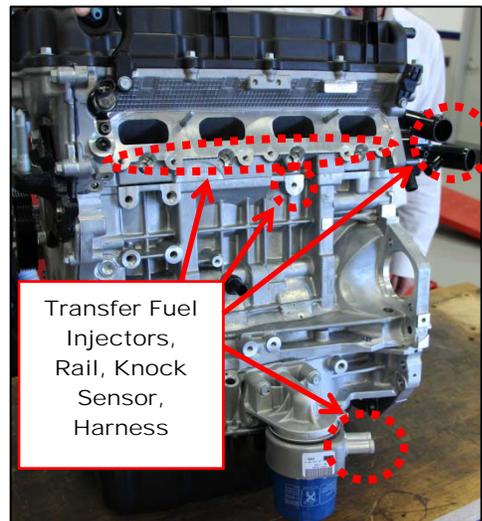
3. Replacement engines must be prepared prior to installation. Some components from the existing engine must be transferred to the new engine.

Be careful to preserve the vehicle's original parts for reinstallation on the replacement engine.
